STRUCTURAL CONDITION ASSESSMENT REPORT

RED, YELLOW, AND GREEN PARKING RAMPS

City Of Appleton

DESMAN Project No. 50-19176

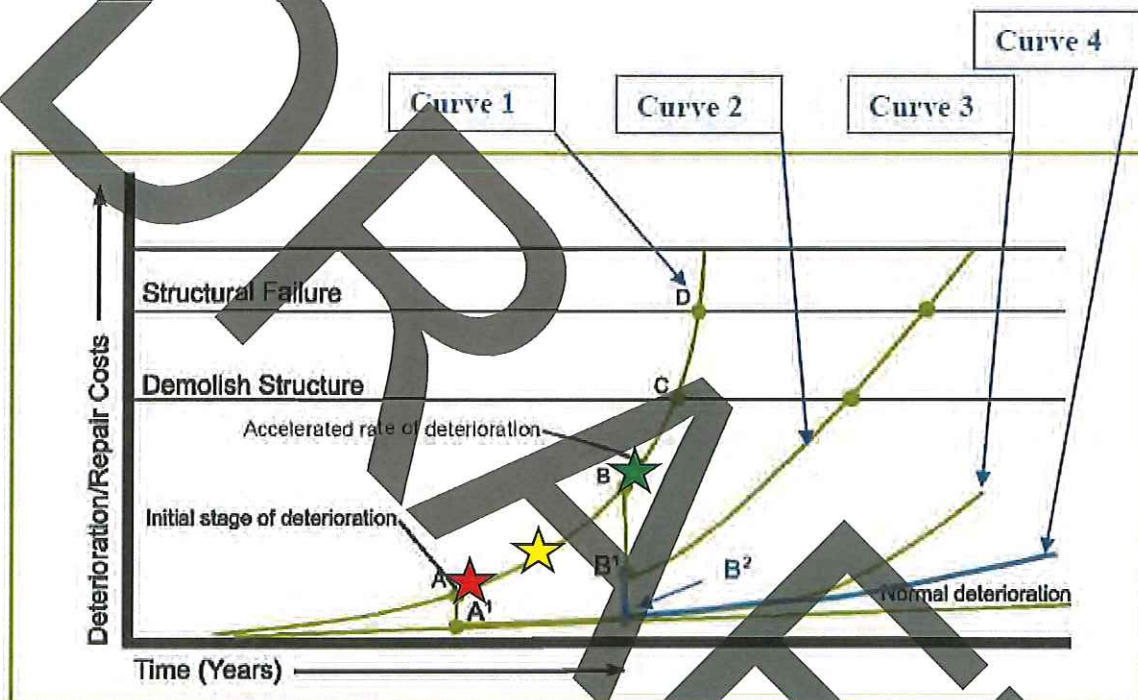
Deterioration of Parking Garages

1. Curve 1 – Expected deterioration or repair costs increases without the recommended repairs (Currently at B & Failure would be expected at D)
2. Curve 2 – Expected ongoing deterioration after recommended repairs move structure from B to B¹
3. Curve 3 – Expected ongoing deterioration after recommended repairs and preventive maintenance move the structure from B¹ to B² and deterioration continues at a reduced rate.
4. Curve 4 – Expected ongoing deterioration after recommended repairs, preventive maintenance, and corrosion inhibitors, and waterproofing membrane move the structure from B¹ to B² and deterioration continues at a further reduced rate (blue line).

Points A–D represent stages of accelerated deterioration in parking structures. Structures repaired at Point A cost less overall and last longer than structures repaired at Point B. Compare curve at A¹ to curve at B¹.
Figure 1- Deterioration of Parking Structures and Ongoing Repair Costs

Each of these curves represent increased repair and maintenance costs to achieve increased durability and reduced ongoing deterioration. The color-coded stars represent the estimated position of each garage on the deterioration curve. The red garage is at position A which represents a point in time where the deterioration of the garage has remained relatively small. Once repaired the red garage will then move down to point A¹ and follow either curves 3 or 4 depending on which level of preventive maintenance was chosen. The red garage could follow a curve similar in nature to curve 2, but starting from point A¹, if no preventive measures are taken. The Green Garage is roughly located at point B on curve 1. A repair program without preventive maintenance would bring the garage to point B¹ and then follow curve 2. While the repair programs with preventive maintenance programs would bring it point B² and then follow either curve 3 or 4 depending on the extent of preventive maintenance items chosen. The Yellow Garage is located between the Red and Green Garages on curve 1 based upon its level of deterioration. With the initiation of a repair and preventive
