June 30, 2015

Ms. Sue Olson, P.E.  
City of Appleton  
100 North Appleton Street  
Appleton, WI 54911

SUBJECT: Appleton East High School StormTrap Structural Inspection

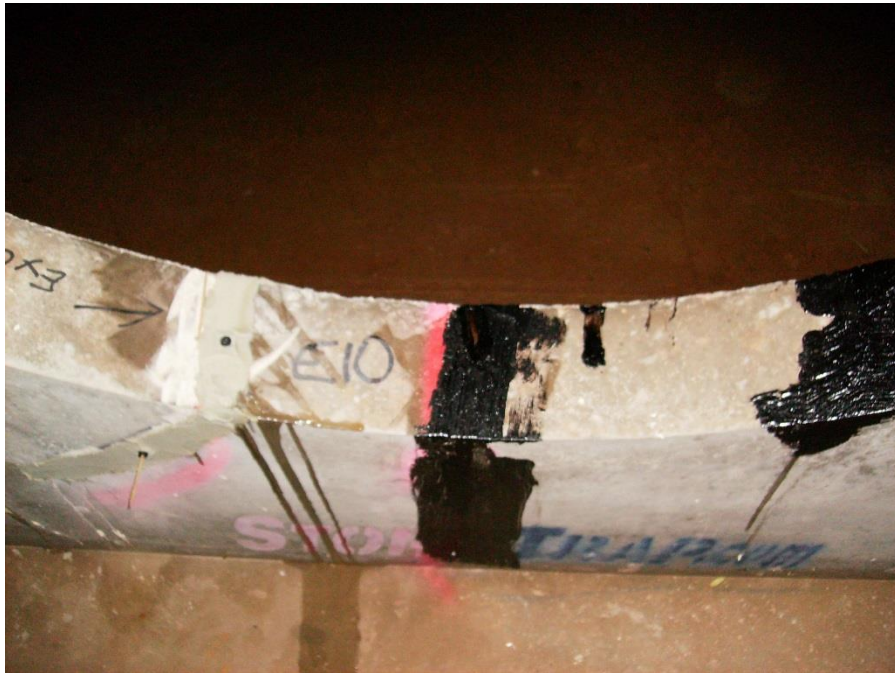
**Phase 1 StormTrap System** – The general condition of the StormTrap units has not appeared to change since the last inspection last year. There were minimal new cracks observed and the new cracks observed were hairline cracks with a width less than .013", thus not requiring repair. The existing repairs appear to be unchanged from a year ago (Photos 1 & 2), except for the following existing repairs:

**Photo 1 – Existing Repair**

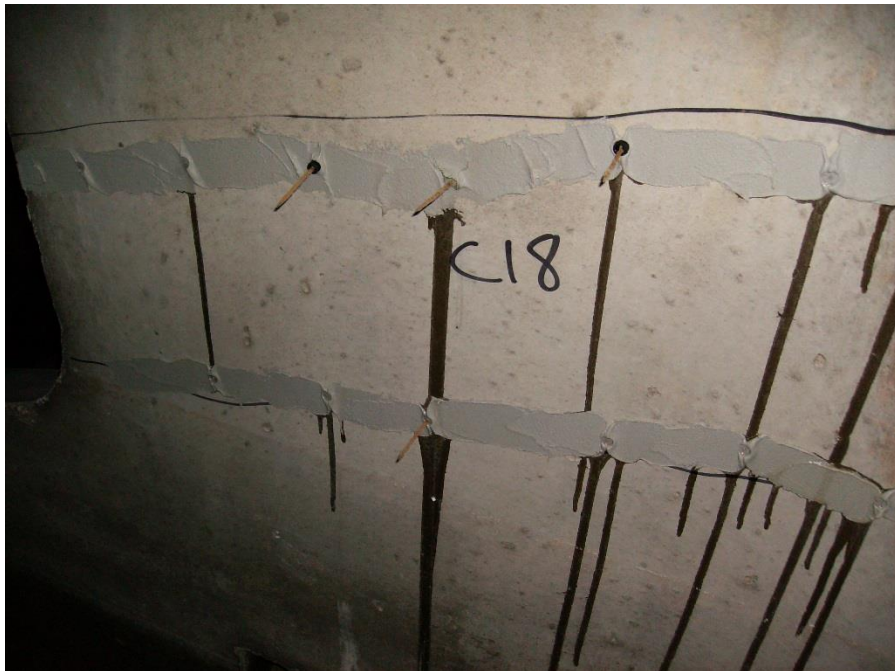
**Photo 2 – Existing Epoxy Repair**

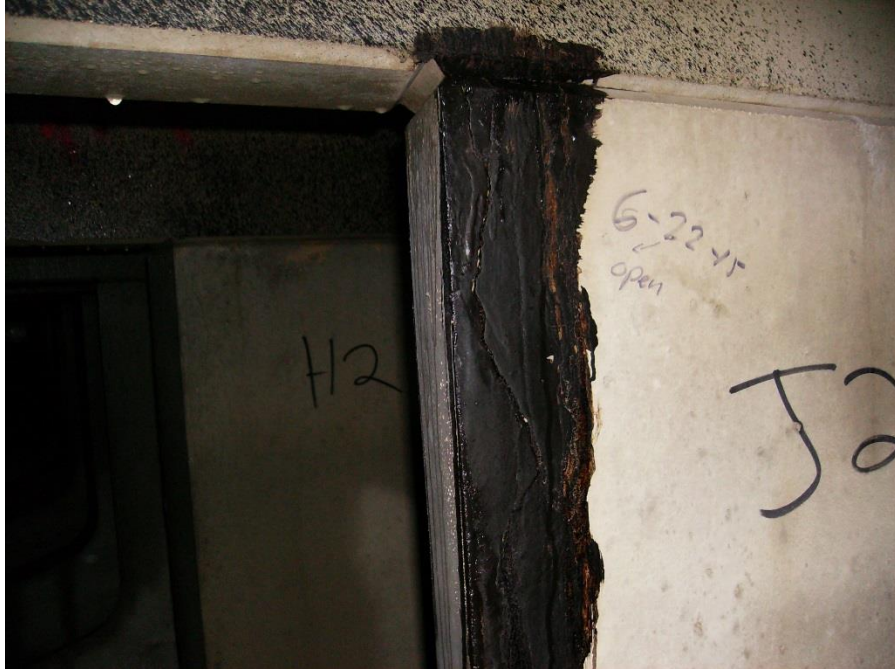
**J2** – Previous crack repair does not appear to have sealed the crack or the crack has opened wider-failing the repair. Crack width is approximately .06", recommend Type 3 Crack Repair. Photo 3

Photo 3 – J2, Open Crack at Repair

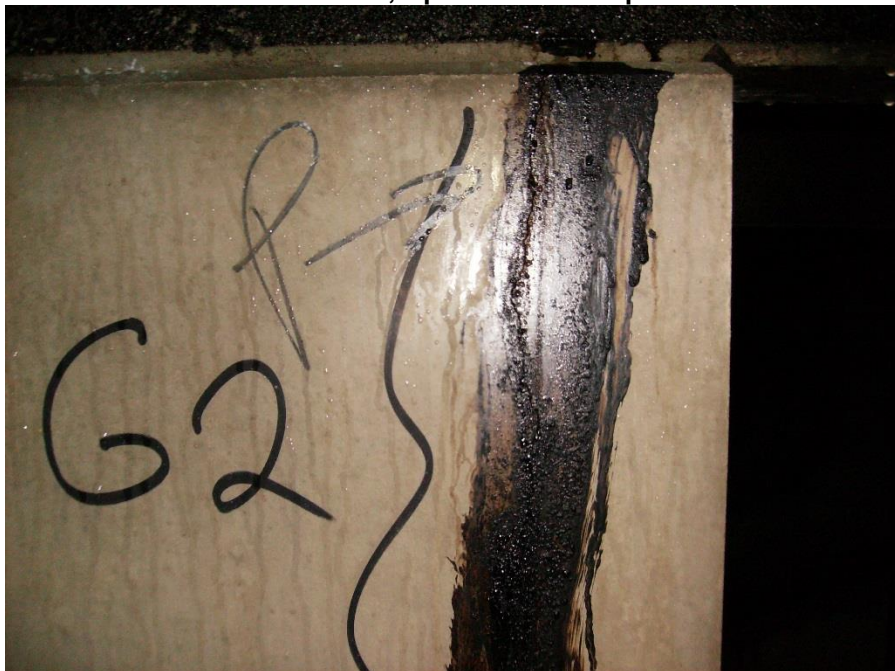
**G2** – Previous crack repair does not appear to have sealed the crack or the crack has opened wider-failing the repair. Crack width is approximately .04", recommend Type 3 Crack Repair. Photo 4

Photo 4 – G2, Open Crack Repair.

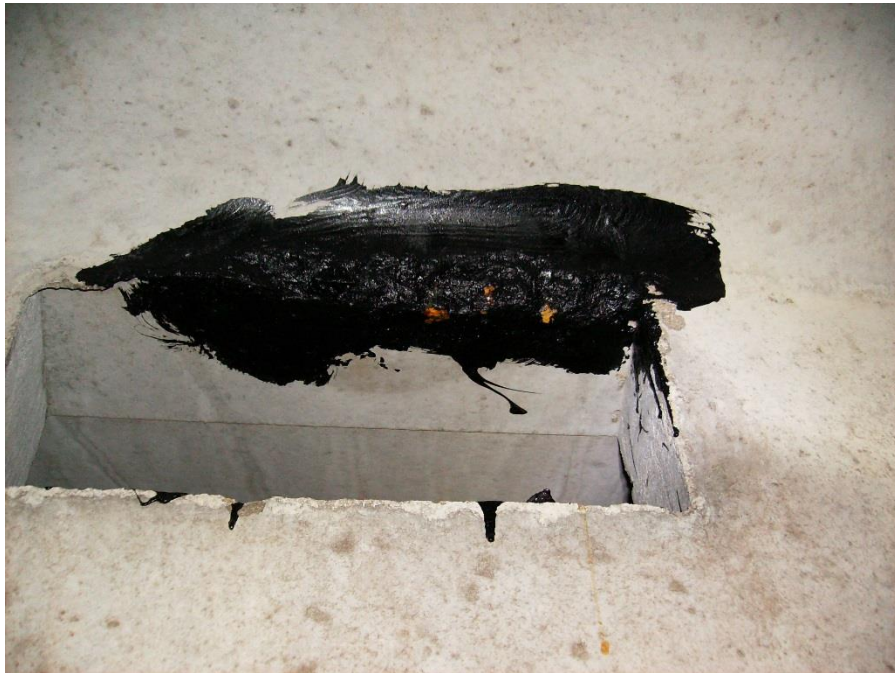
**E31** – Rust is coming through the existing repair. The corrosion appears to be minor, recommend cleaning and recoating. Photo 5

Photo 5 – E31, Minor corrosion at rebar coating.

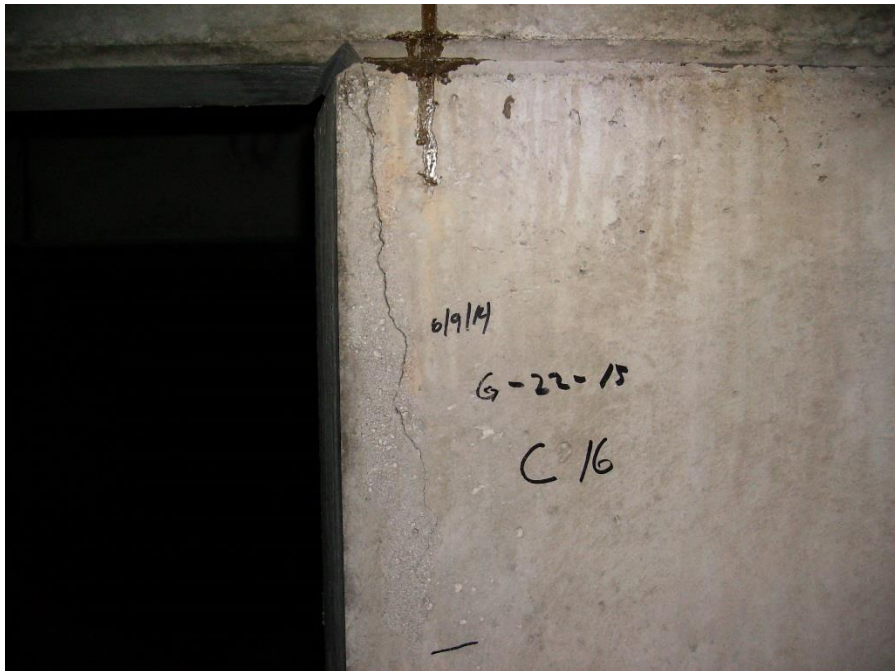
**C16** – One side of crack is not sealed - opposite side was previously sealed. Crack width is approximately .04", recommend Type 2 Crack Repair (similar to opposite side repair) Photo 6

Photo 6 – C16, Side of crack shown not previously repaired.

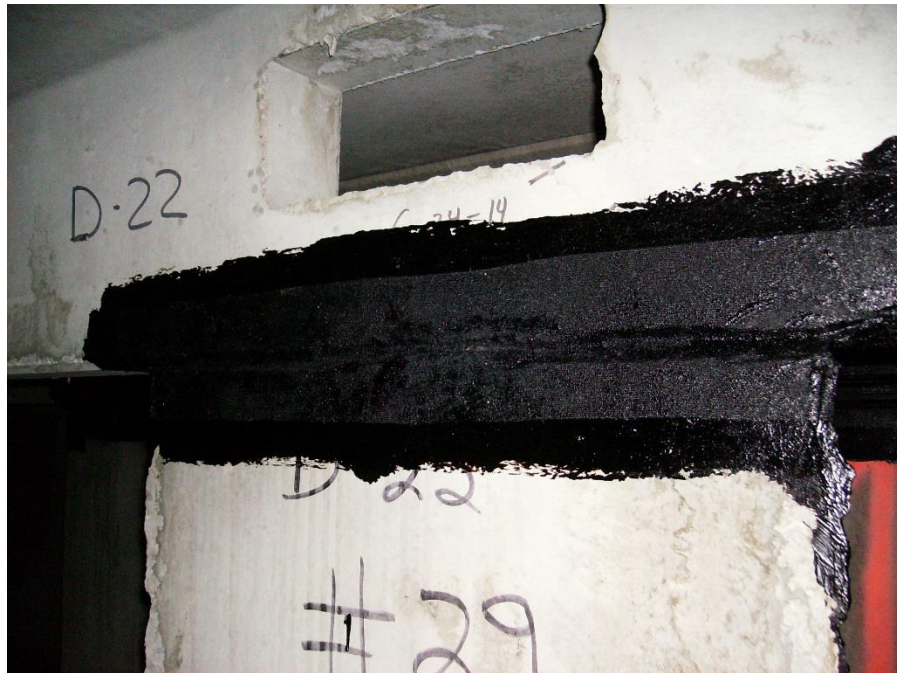
**Phase 2 StormTrap System** – The general condition of the StormTrap units appeared to be very good. Minimal additional hairline cracks (width less than .013”) were observed as well as some extended lengths of existing hairline cracks. Existing repairs appeared to be in sound condition. Photos 7-10. The following deficiencies were noted:

Photo 7 – Shim Protection

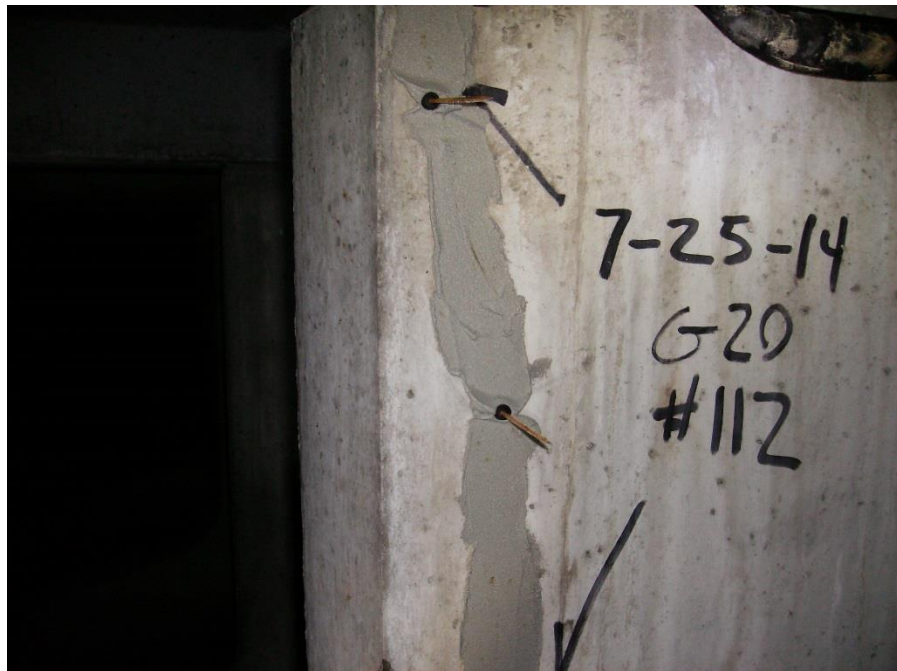
Photo 8 – Previous Repair

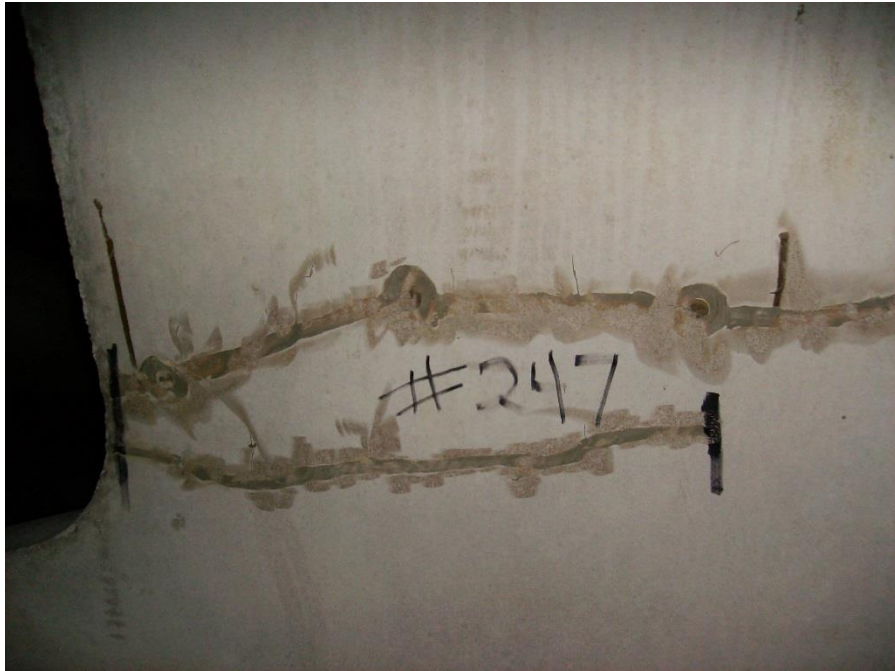
Photo 9 – Previous Repair

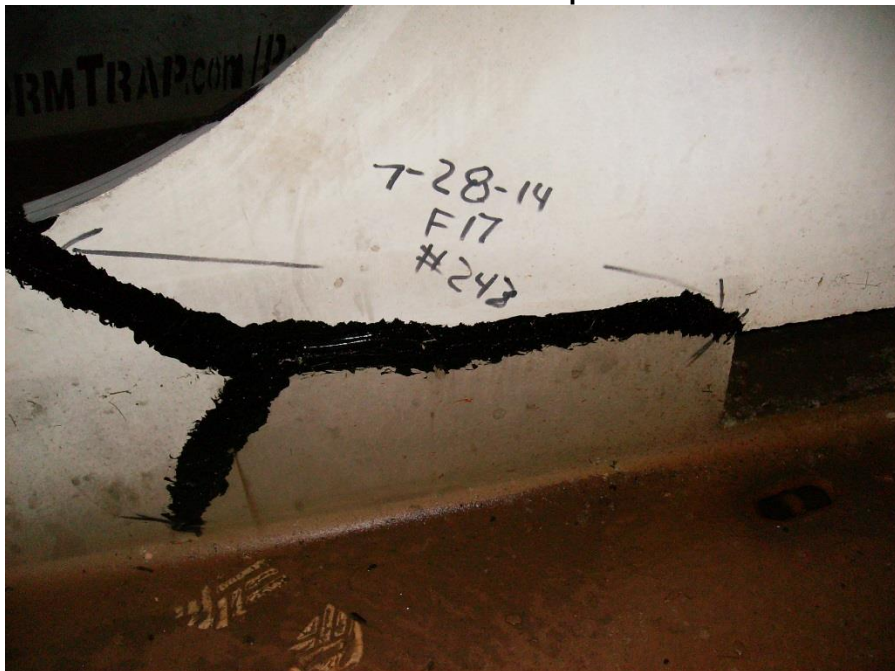
Photo 10 – Previous Repair

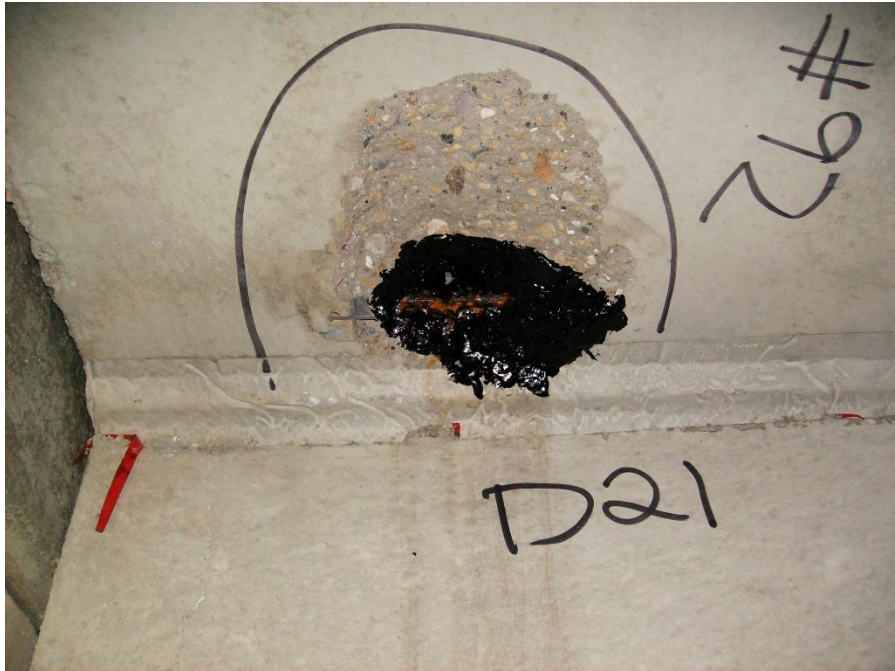
**D21** – Corrosion has started in exposed reinforcing that was previously coated. Recommend cleaning and recoating. Photo 11

Photo 11 – D21, Minor corrosion at repair.

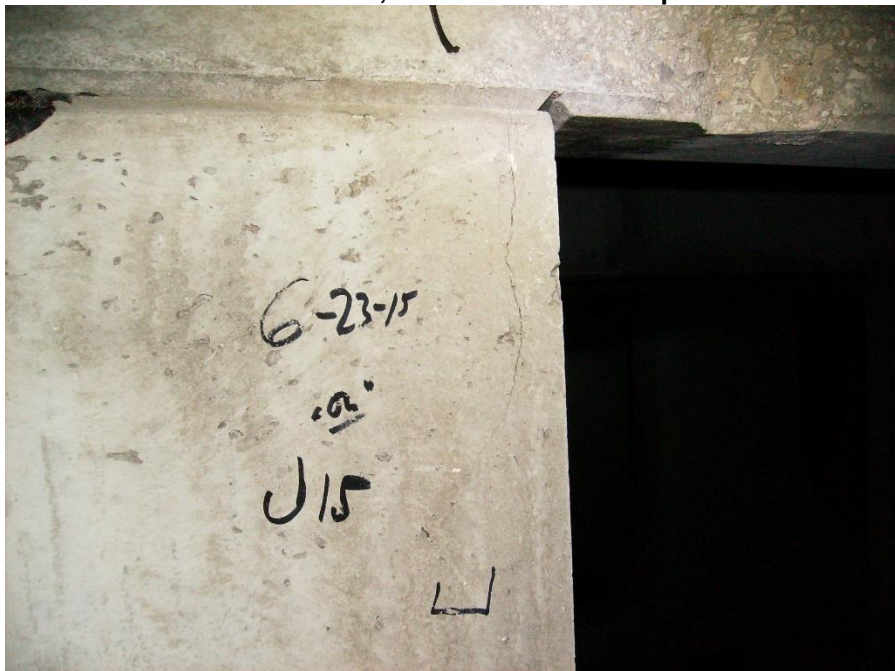
**J15** - .02” wide crack in West vertical leg. Recommend Type 2 Crack Repair. Photo 12

Photo 12 – J15, Vertical Crack

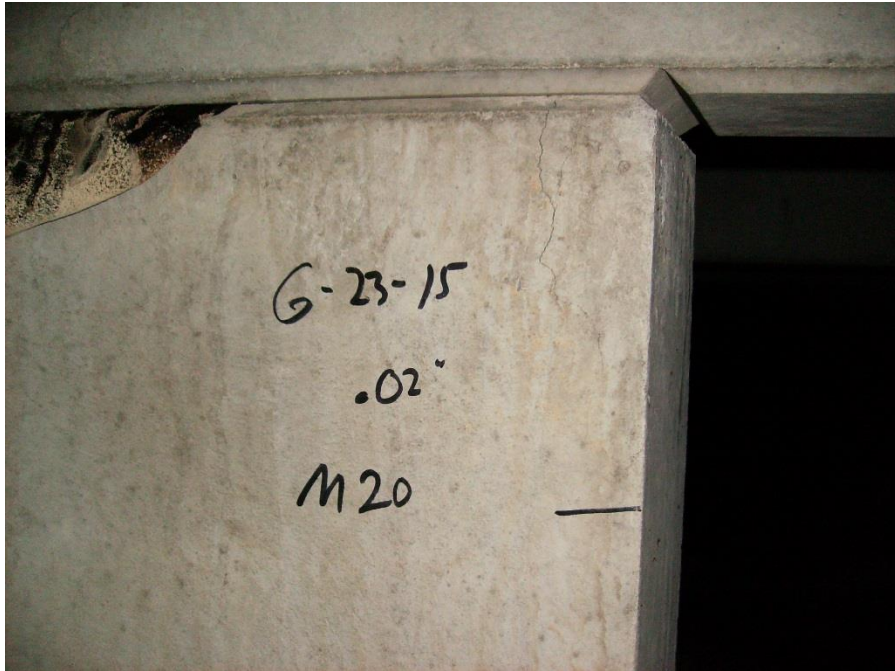
**M20** - .02” wide crack in West vertical leg. Recommend Type 2 Crack Repair. Photo 13

Photo 13 – M20, Vertical Crack

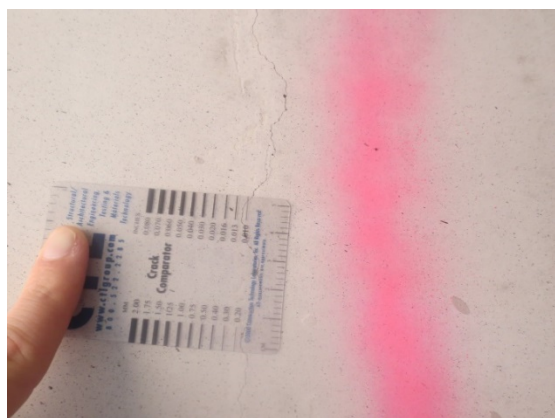
Figure 1

The first type of crack which may be observed is a crack which would be 0.013" or smaller in width. These are cracks which are typically observed as a result of the shipment process and are identified as 'aesthetic' cracking. These cracks do not pose any structural concern and require no attention. An example of this can be seen in Figure 1.

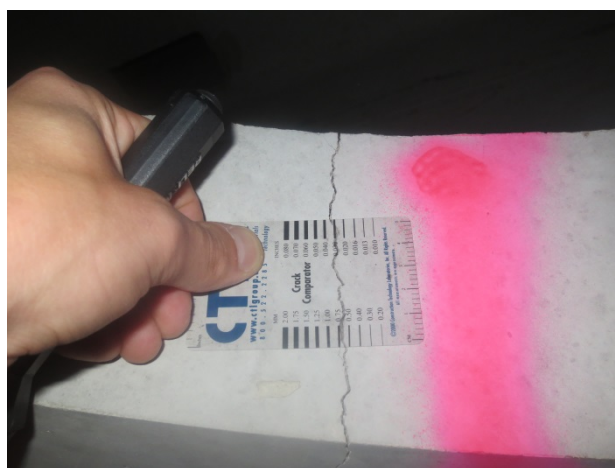
The second type of crack which can occur is identified as being greater than 0.013" and equal to or less than 0.040" in width. Structurally, the only concern with this crack is potential migration of water into the crack which in long term applications could promote corrosion of the internal structural steel. Therefore, simply a sealant over the crack is suggested to deter water from permeating further into the precast section. Sikadur Crackfix is suggested for use in these applications to 'cover' the crack. Manufacturer's specifications should be followed in applying the material correctly and a Sika representative should be contacted for any clarification or questions regarding application (Product Detail Sheet attached). See Figure 2 for an example.

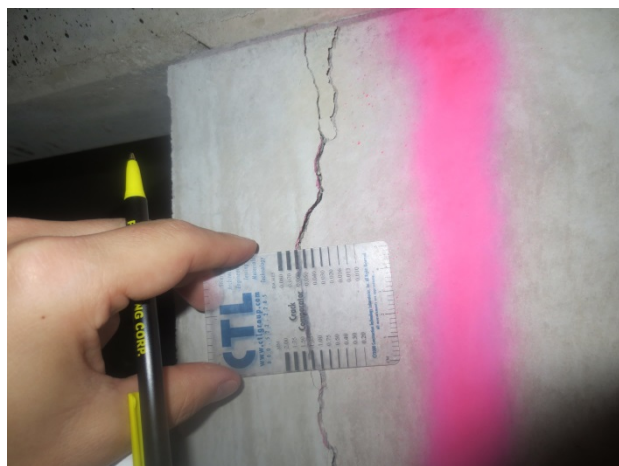
Figure 3

The third type of crack which could be encountered is identified as being greater than 0.040" and equal to or less than 0.080" in width. Cracks at this width require a 'structural material' to impregnate the gap and provide a structural transference of load through the crack. These cracks, as identified in Figure 3, should be repaired using a structural epoxy injection. Sikadur 35, Hi-Mod LV LPL is recommended for this application. Manufacturer's specifications should be followed in applying the material correctly and a Sika representative should be contacted for any clarification or questions regarding application (Product Detail Sheet attached).
