# Phase II Subsurface Investigation

222 North Oneida Street  
Outagamie County Tax Parcel 312038400  
City of Appleton, Outagamie County, WI

City of Appleton  
100 N. Appleton St.  
Appleton, WI 54911

November 22, 2017

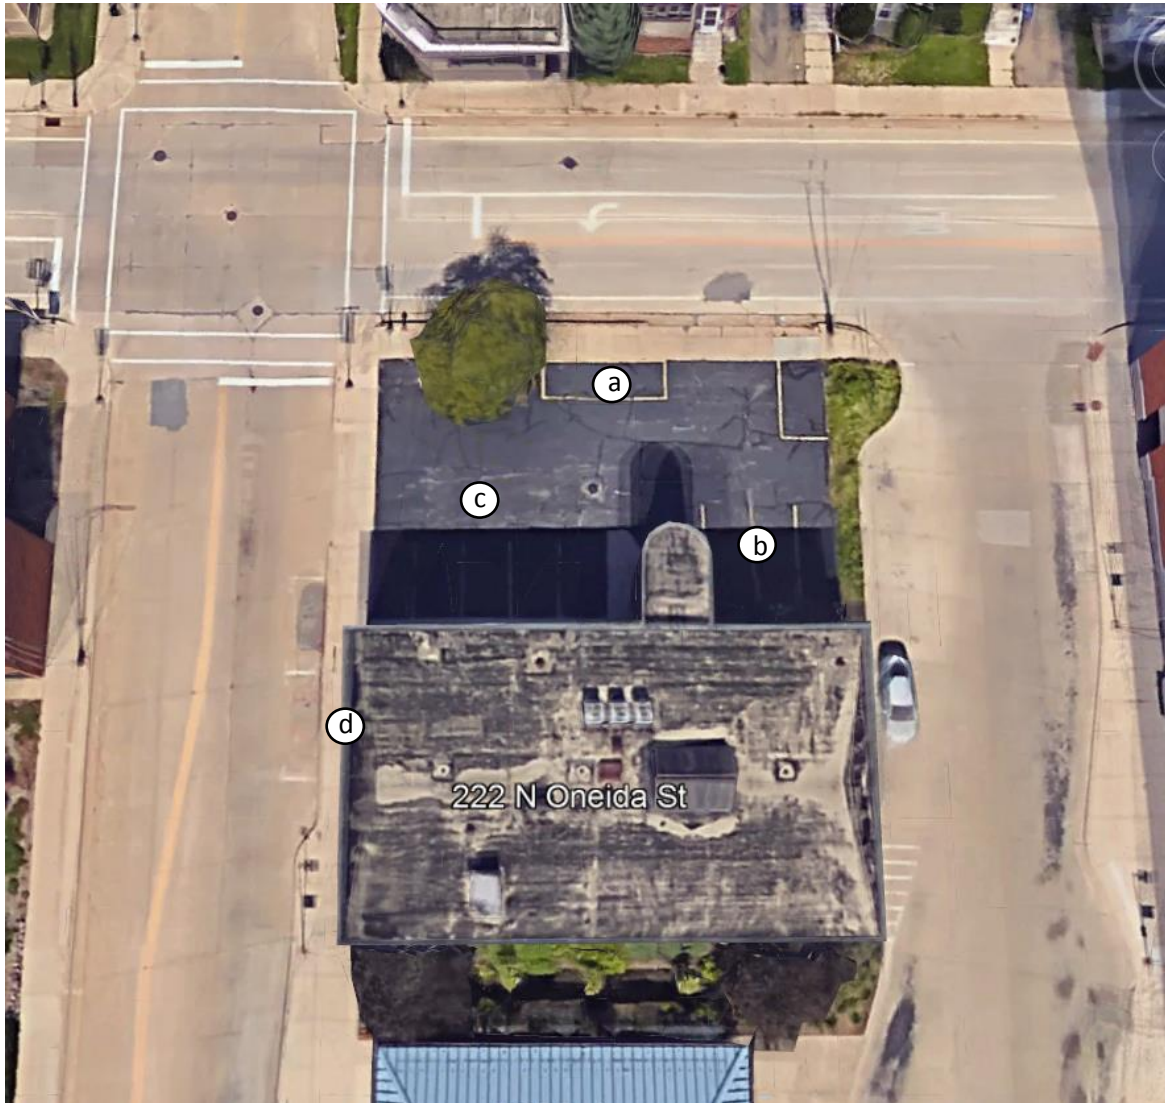
## Site Detail Map

- a) Four underground storage tank locations listed in 1951
- b) Former location of automotive service bay
- c) Two underground storage tank locations listed in 1951
- d) Fill port location for former fuel oil tank in basement

On November 3, 2017, OMNNI coordinated the installation of ten geoprobe soil borings (SB-01 – SB-10) on the subject property. (See Site Detail Map, and Geoprobe Locations, Appendix 1.) The borings were based on the locations depicted on the 1951 and 1970 Sanborn maps of the gas tanks, the service center, and rental car facility. Borings SB-01-SB-04, SB-09, and SB-10 were placed in the northern portion of the parking lot to determine potential impacts of underground storage tanks along the north property line. Borings SB-05, SB-7, and SB-08 were installed to characterize conditions associated with tanks formerly located in the western portion of the parking lot area. Boring B06 was placed in the southeast portion of the parking lot where there was a former service bay. An additional boring was proposed on the west side of the building; however, due to utility conflicts, the area was not investigated further.

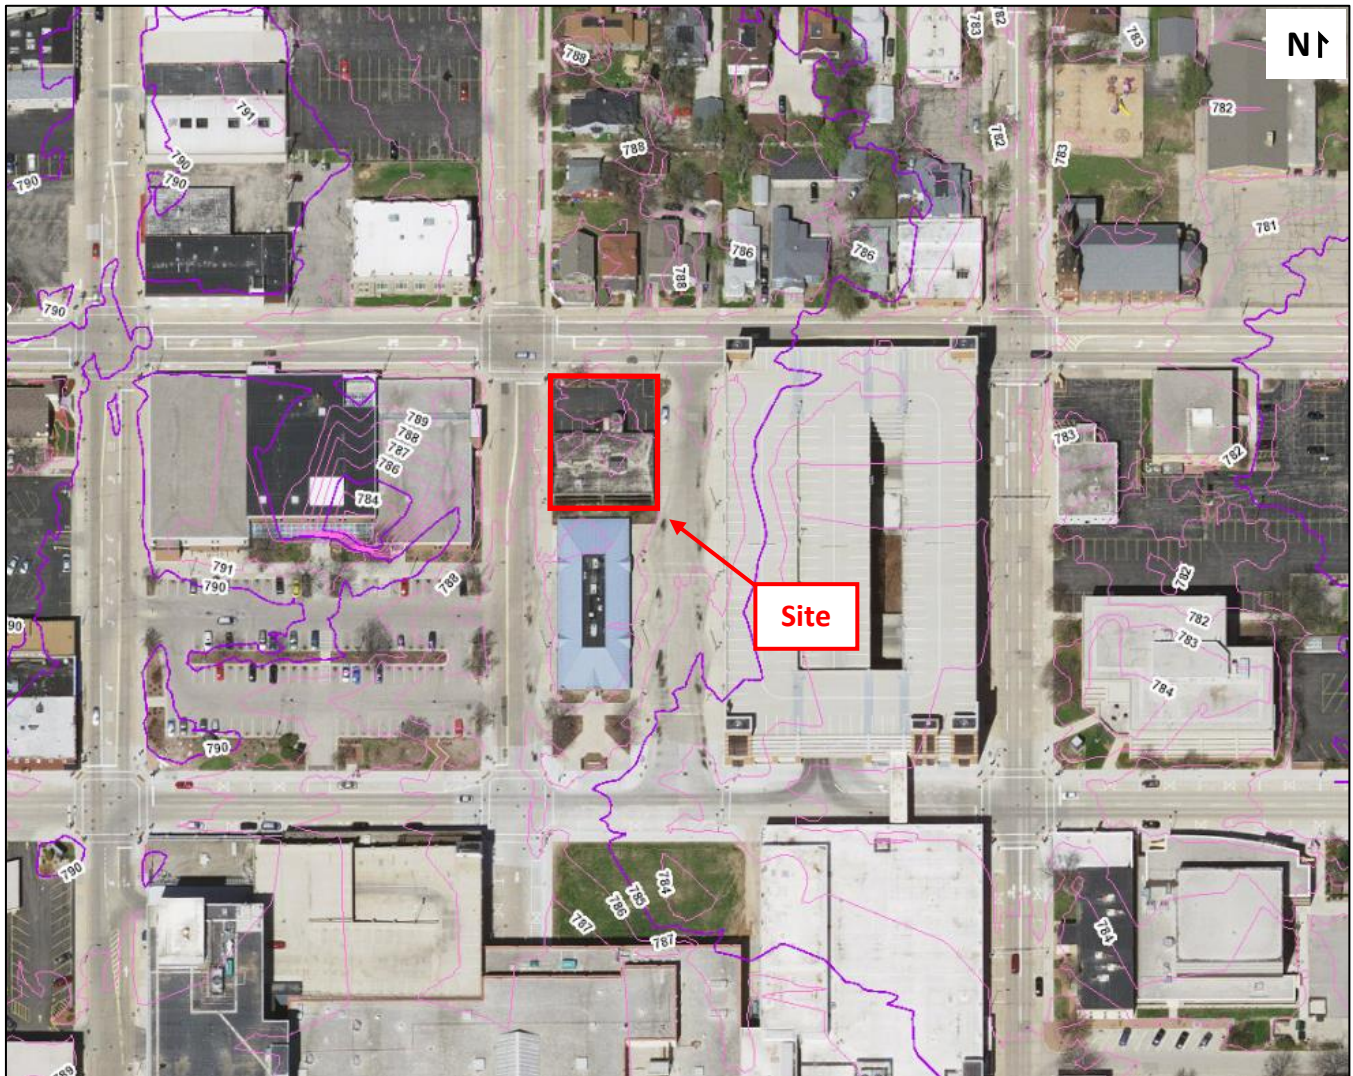
## Topographic Map

Contour interval is one foot.

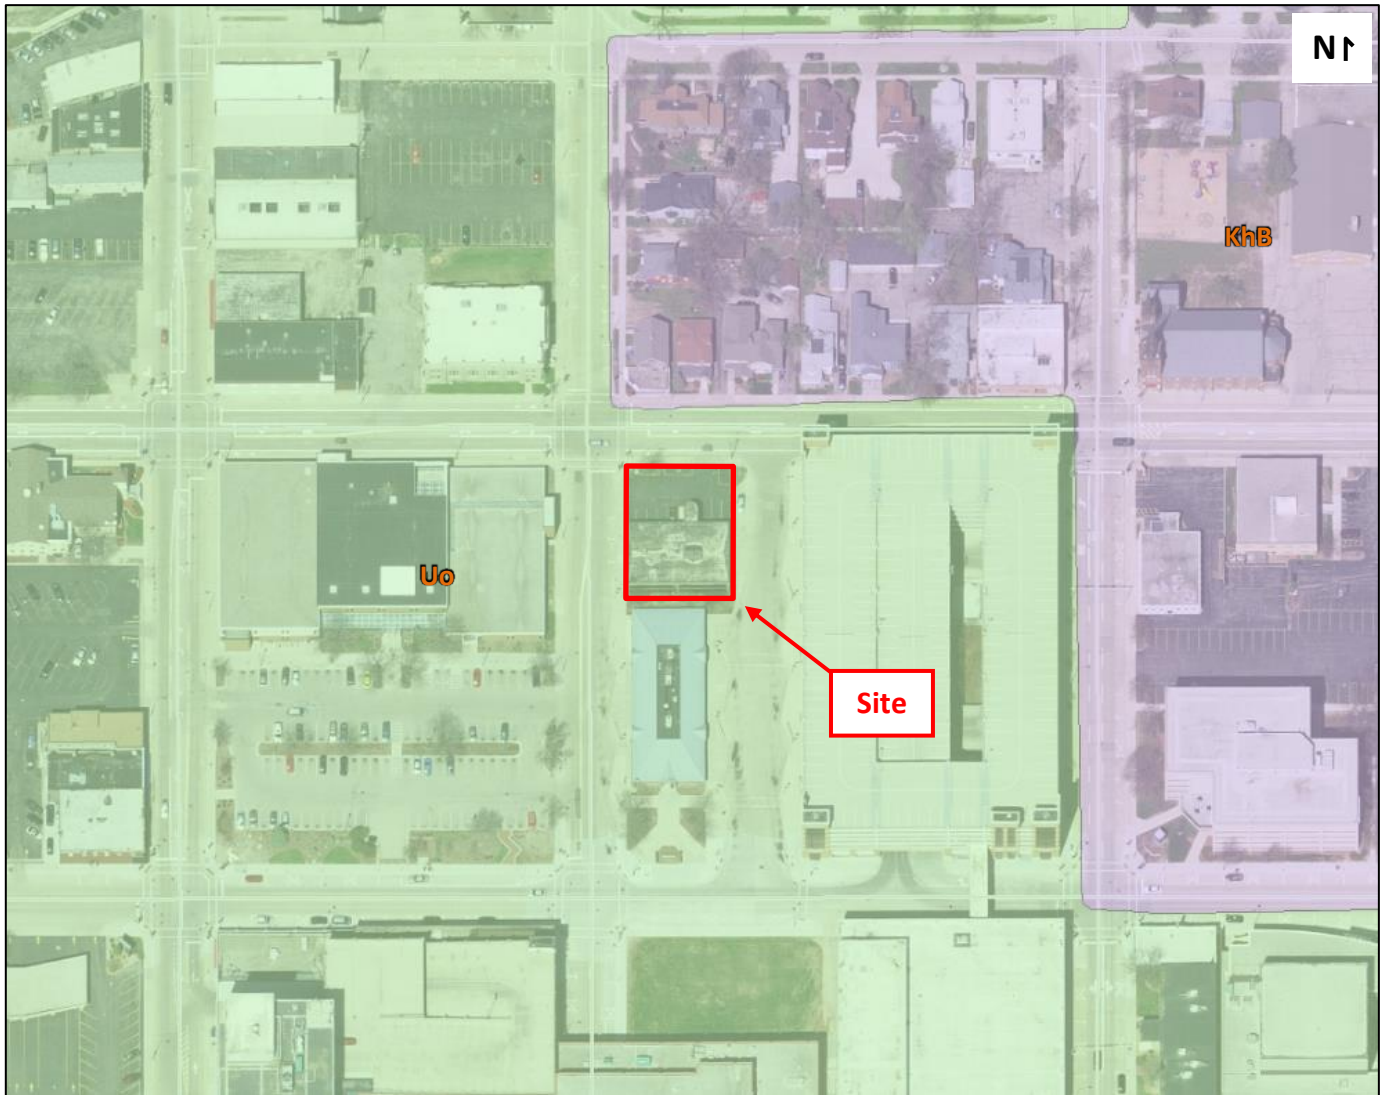
## Soil Map

Udorthents (Uo) – somewhat excessively drained disturbed fill lands

Kewaunee silt loam, 2 – 6% slopes (KhB) – well drained
